Materials and Manufacturing

Introduction

Nondestructive Testing Innovations

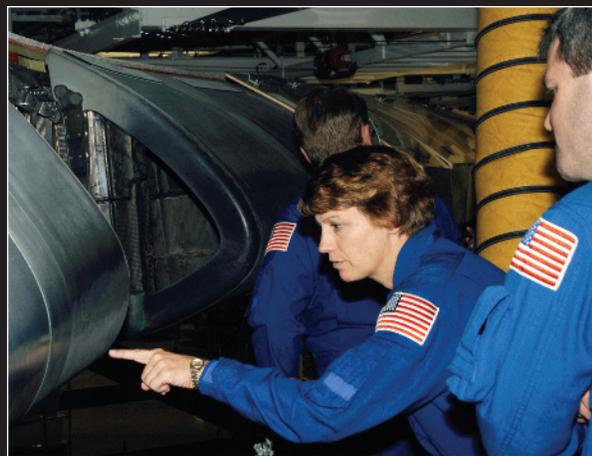
Left, a gardener checks ripening vegetables. Right, Astronaut Eileen Collins, STS-114 (2005) mission commander, looks closely at a reinforced carbon-carbon panel on one of the wings of the Space Shuttle Atlantis in the Orbiter Processing Facility at Kennedy Space Center (KSC). Collins and the other crew members were at KSC to take part in hands-on equipment and Orbiter familiarization.

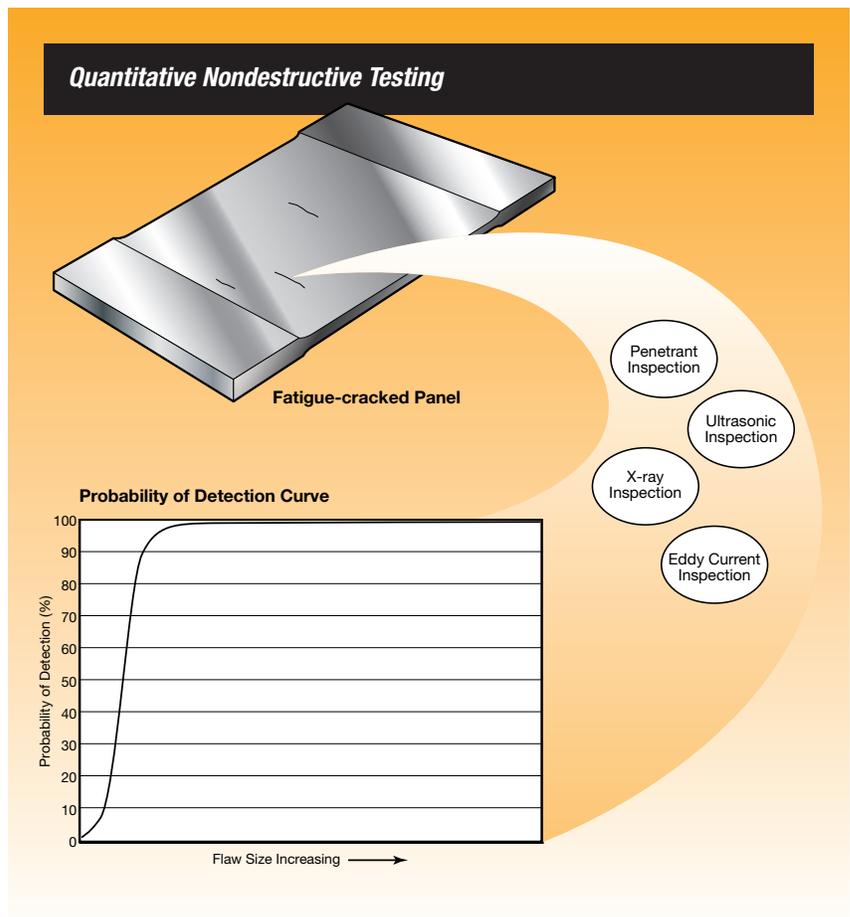
The special probability of detection specimen sets typically consisted of 29 randomly distributed cracks of approximately the same size. By detecting all 29 cracks, the inspector and the specific nondestructive evaluation process were considered capable of detecting the crack size to a 90% probability of detection with 95% confidence.

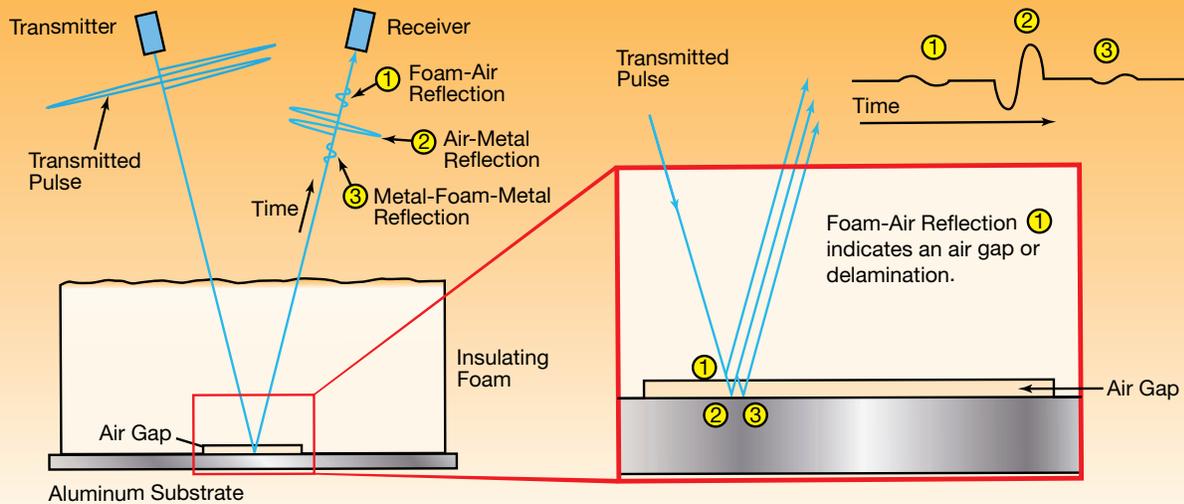
Terahertz Imaging System

This system uses high-frequency electromagnetic pulses.

Terahertz imaging is a method that operates in the terahertz region of the electromagnetic spectrum between microwave frequencies and far-infrared frequencies. Low-density hydrocarbon materials like External Tank foam were relatively transparent to terahertz radiation. Terahertz imaging used a pulser to transmit energy into a structure and a receiver to record the energy reflected off the substrate or internal defects. As the signal traveled through the structure, its basic wave

properties were altered by the attenuation of the material and any internal defects. An image was made by scanning the pulser/receiver combination over the foam surface and displaying the received signal.

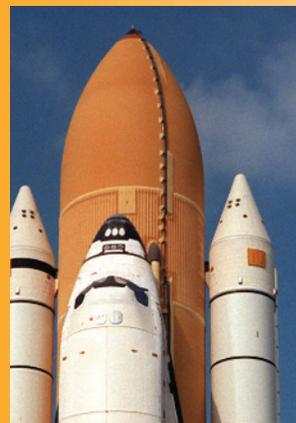
Backscatter X-ray Imaging System

Insulating foam covers the External Tank.

test material are reradiated at a lower energy as secondary x-rays in all directions. The reradiated or backscattered x-rays were collected in collimated radiation detectors mounted around the x-ray source. Voids or defects in the test material were imaged in backscatter radiography in the same manner as they were in conventional through-transmission radiography. Imaging of voids or defects depended on less absorbing material and less backscattered x-rays from the void.

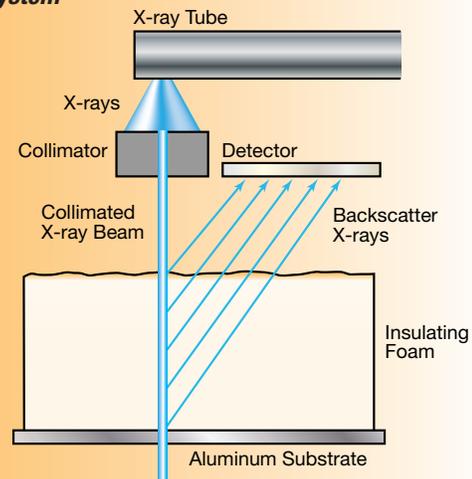
An irradiated column of foam that has voids produces less backscattered x-rays than a void-free column of foam.

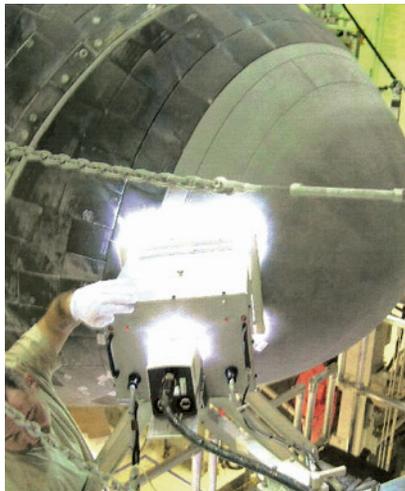
Infrared thermography inspection of the Orbiter nose captured at the instant of the xenon lamp flash. Kennedy Space Center Orbiter Processing Facility.

The Thermographic Inspection System was an active infrared flash thermography system. Thermographic inspection examined and recorded the surface temperature transients of the test article after application of a short-duration heat pulse. The rate of heat transfer away from the test article surface depended on the thermal diffusivity of the material and the uniformity and integrity of the test material. Defects in the material would retard the heat flow away from the surface, thus producing surface temperature differentials that were reflective of the uniformity of the material and its defect content. A defect-free material would uniformly

transfer heat into the underlying material, and the surface temperature would appear the same over the entire test surface; however, a delamination would prevent or significantly retard heat flow across the gap created by the delamination, resulting in more-local heat retention and higher surface temperature in comparison to the material surrounding the delamination. Temperature differences were detected by the infrared camera, which provided visual images of the defects. Electronic signals were processed and enhanced for easier interpretation. The heat pulse was provided by flashing xenon lamps in a hooded arrangement that excluded ambient light. The infrared camera was transported along a floor-mounted rail system in the Orbiter Processing Facility for the leading edge panel inspections, allowing full and secure access to all of the leading edge surfaces. After the transport cart was positioned, the camera was positioned manually via a grid system that allowed the same areas to be compared from flight to flight.

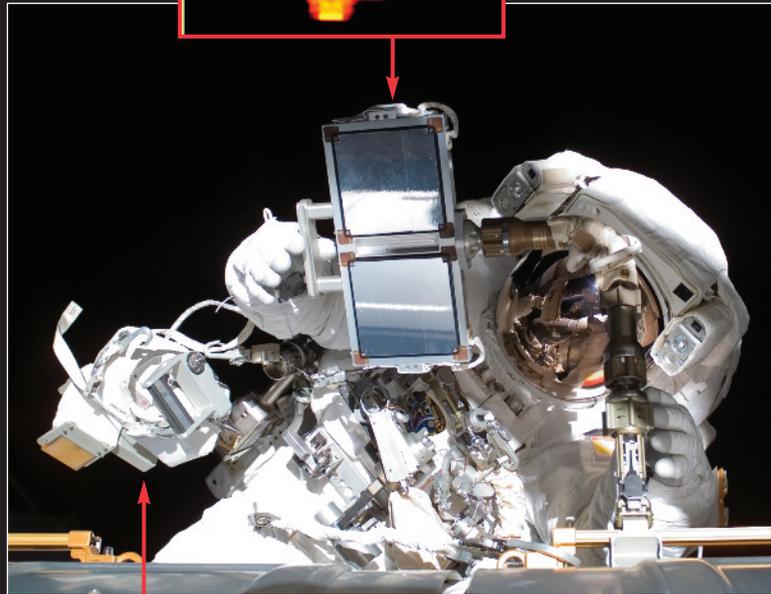
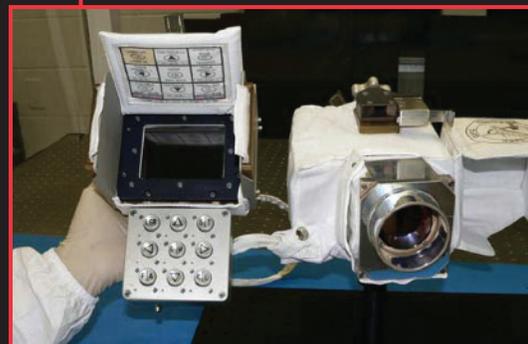
Extravehicular activity infrared flight camera.

With the feasibility of on-orbit thermography demonstrated and with the spaceflight limitations on weight and power taken into account, NASA selected a commercial off-the-shelf microbolometer camera for modification and development into a space-qualified infrared camera for inspecting the reinforced carbon-carbon for impact damage while on orbit.

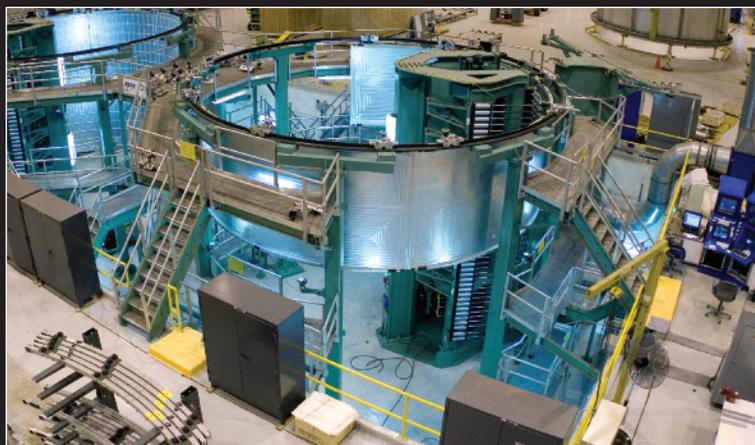
Friction stir welding units, featuring auto-adjustable pin tools, welded External Tank barrel sections at NASA's Michoud Assembly Facility in New Orleans, Louisiana. The units measured 8.4 m (27.5 ft) in diameter and approximately 7.6 m (25 ft) tall to accommodate the largest barrel sections.

During 2002-2003, NASA and the External Tank prime contractor, Lockheed Martin, implemented auto-adjustable pin tool friction stir welding for liquid hydrogen and liquid oxygen tank longitudinal welds. Since that time, these friction stir welds have been virtually defect-free. NASA's invention was being used to weld Ares upper-stage cryogenic hardware. It has also been adopted by industry and is being used in the manufacturing of aerospace and aircraft frames.

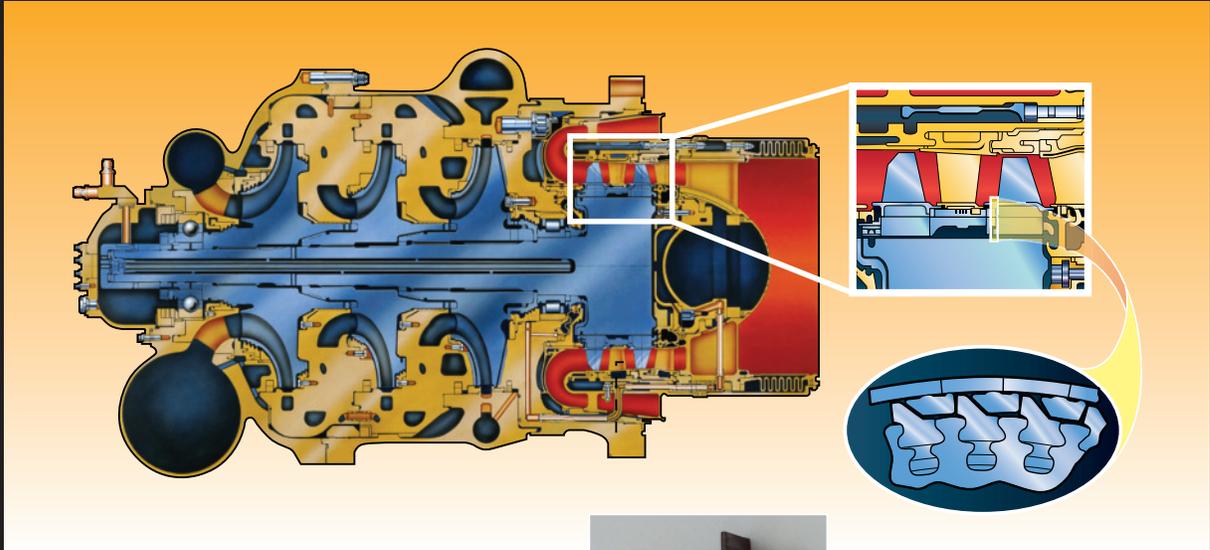
High-Pressure Fuel and Oxidizer Turbopump Turbine Blade Cracks

After observing cracks on polycrystalline turbine blades, NASA redesigned the blades as single-crystal parts. When tested in hydrogen, cracks were detected. Scientists used a Brazilian disc test to create the tensile and shear stresses that had caused growth. NASA resolved cracking in the airfoil with changes that eliminated stress concentrations and smoothed the flow of molten metal during casting. To assess cracking at damper contacts, scientists extracted test specimens from single crystal bars, machined contact pins from the damper material, and loaded two specimens. This contact fixture was supported in a test rig that allowed the temperature, loads, and load cycle rate to be varied. Specimens were pre-charged with hydrogen, tested at elevated temperatures, and cycled at high frequency to actual operating conditions.

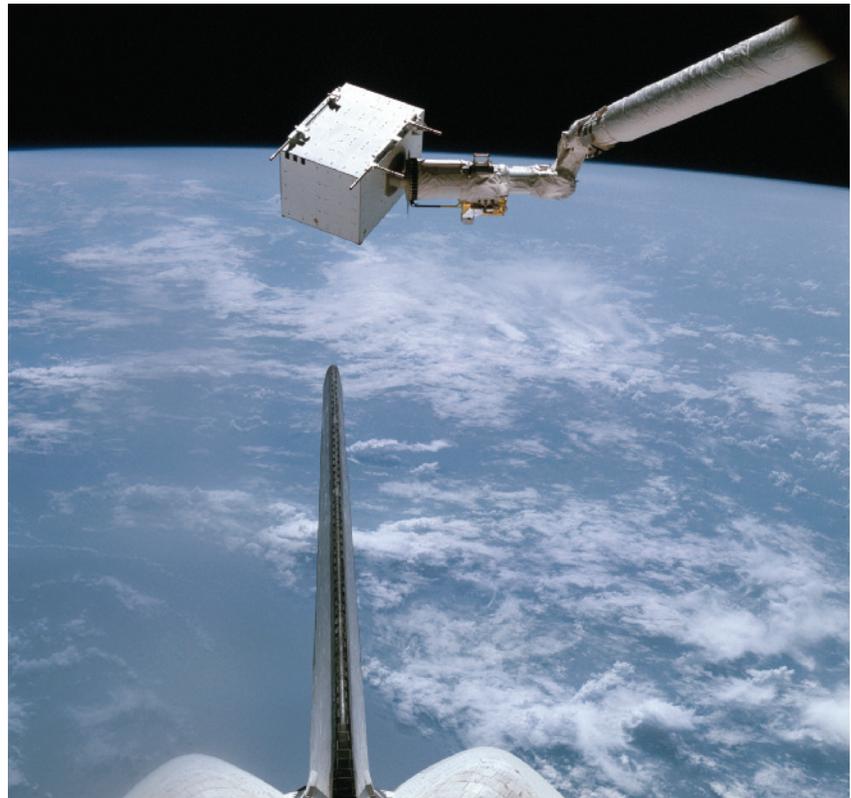
The Atlantic Ocean southeast of the Bahamas is in the background as Columbia's Shuttle Robotic Arm and end effector grasp a multi-instrument monitor for detecting contaminants. The experiment, called the Induced Environment Contaminant Monitor, was flown on STS-4 (1982). The tail of the Orbiter can be seen below.

The Induced Environment Contamination Monitor measured the induced environment on three missions—Space Transportation System (STS)-2 (1981), STS-3 (1982), and STS-4 (1982)—and was capable of being moved using the Shuttle Robotic Arm to various locations for specific measurements. Most measurements were made during the on-orbit phase. This measurement package was flown on the three missions to assess shuttle system performance. Instruments included a humidity monitor, an air sampler for gas collection and analysis after return, a cascade impactor for particulate measurement, passive samples for optical degradation of

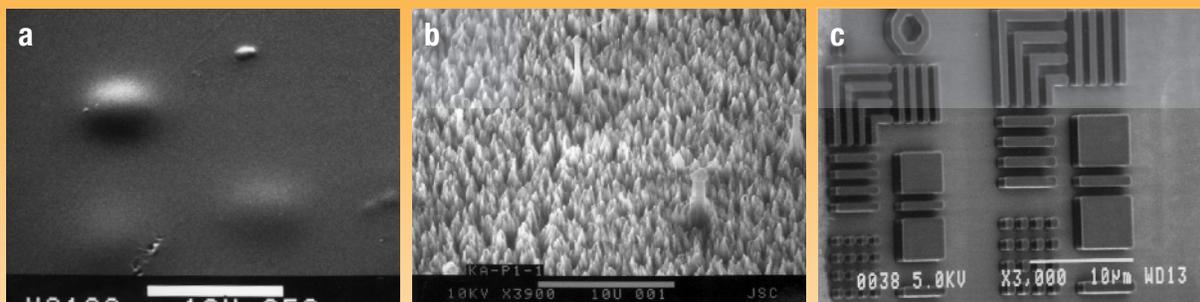
Atomic Oxygen Effects on Polymers and Plastics in low-Earth Orbit as Seen With the Scanning Electron Microscope; STS-46 (1992)

- Scanning electron microscope image of a typical Kapton® polyimide plastic sheet. The various specs and bumps are from the inorganic filler used in plastic sheet manufacture.

- Scanning electron microscope image of a typical Kapton® polyimide plastic sheet after exposure to surface bombardment by atomic oxygen in low-Earth orbit. The rough surface is typical of atomic oxygen attack on plastics in low-Earth orbit and is the result of the strong dependence of chemical reaction on atom-surface collision energy. Note how some of the inorganic filler particles are standing on pedestals because they protect the underlying plastic from atomic oxygen attack.

Patterns on modified surfaces indicated directional effects and, surprisingly, the flight-exposed surfaces were found to have receded rather than having deposited contaminants. The patterns on the surfaces were related to the

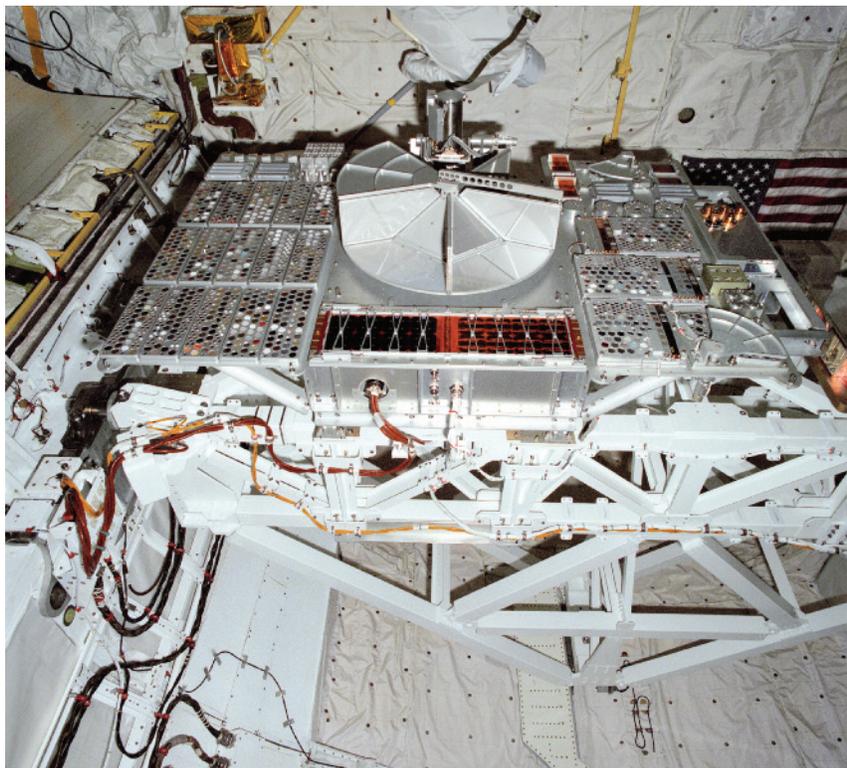
Evaluation of Oxygen Interaction with Materials III flight experiment in the Orbiter payload bay of STS-46 (1992). Material exposure samples are located on both sides of the mass spectrometer gas evolution measurement assembly in the center.

NASA achieved all of the Evaluation of Oxygen Interaction with Materials III objectives during STS-46. A well-characterized, short-term, high-fluence atomic oxygen exposure was provided for a large number of materials, many of which had never been exposed to a known low-Earth orbit atomic oxygen environment. The data provided a benchmark reaction rate database, which has been used by the International Space Station, Hubble, and others to select materials and coatings to ensure long-term durability.

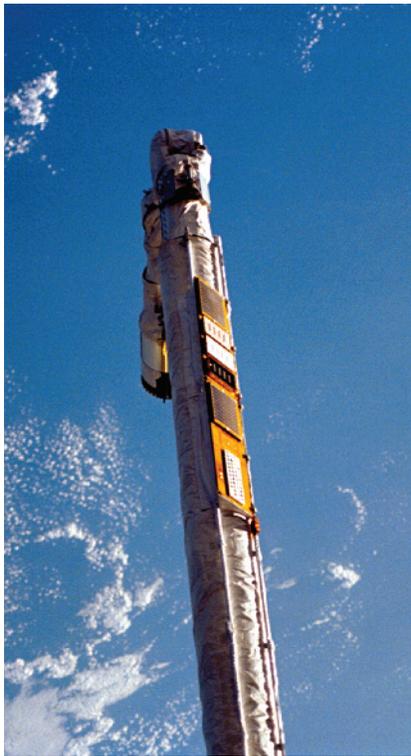
The Intelsat Solar Array Coupon flight experiment shown mounted on the Shuttle Robotic Arm lower arm boom and exposed to space environment conditions during STS-41 (1990).

To provide facts needed for a final decision about a rescue flight, NASA designed and executed the Intelsat Solar Array Coupon flight experiment on STS-41 (1990). The experiment results, in combination with ground-based testing, supported the decision to conduct the STS-49 satellite rescue mission. On this mission, Intelsat 603 was captured and equipped with a solid re-boost motor to carry it to successful geosynchronous orbit.

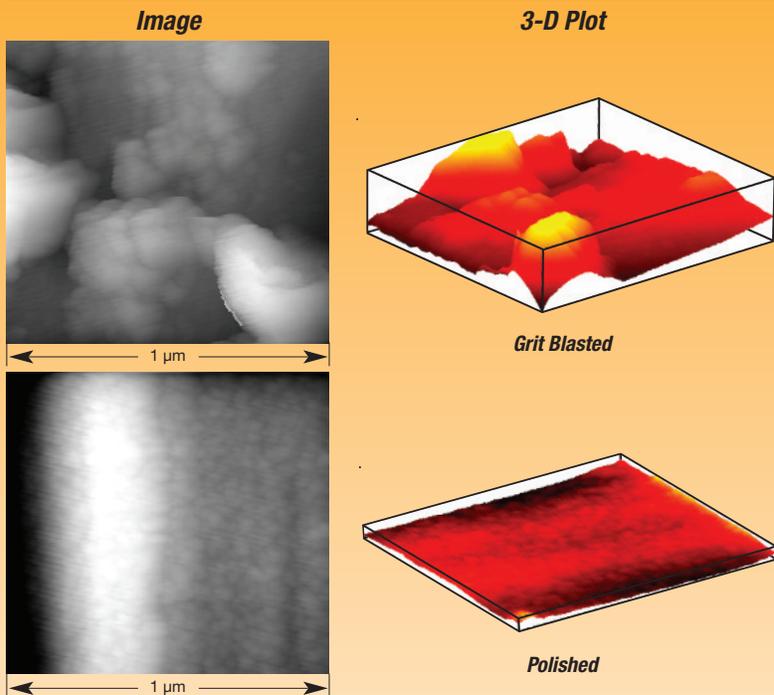
Tools for Materials Evaluation
Atomic Force Microscope Images of Metal Surface

The atomic force microscope affords a visual evaluation of surface preparation processes to improve understanding of their effects on bonding. The top panel represents topography of a grit blast surface for comparison to a highly polished one. The atomic force microscope uses an extremely fine probe to measure minute interactions with surface features even down to an atomic scale. The maps at left are scaled from black at the bottom of valleys to white at the tops of peaks within the scanned area. The 3-D projections at right are on a common height scale. The grit blast surface clearly offers greatly increased surface area and mechanical interlocking for enhanced bonding. Beyond simple topography, the probe interactions with atomic forces can also measure and map properties such as microscopic hardness or elastic modulus on various particles and/or phase transitions in a composite material, which in turn can be correlated with chemical and physical properties.

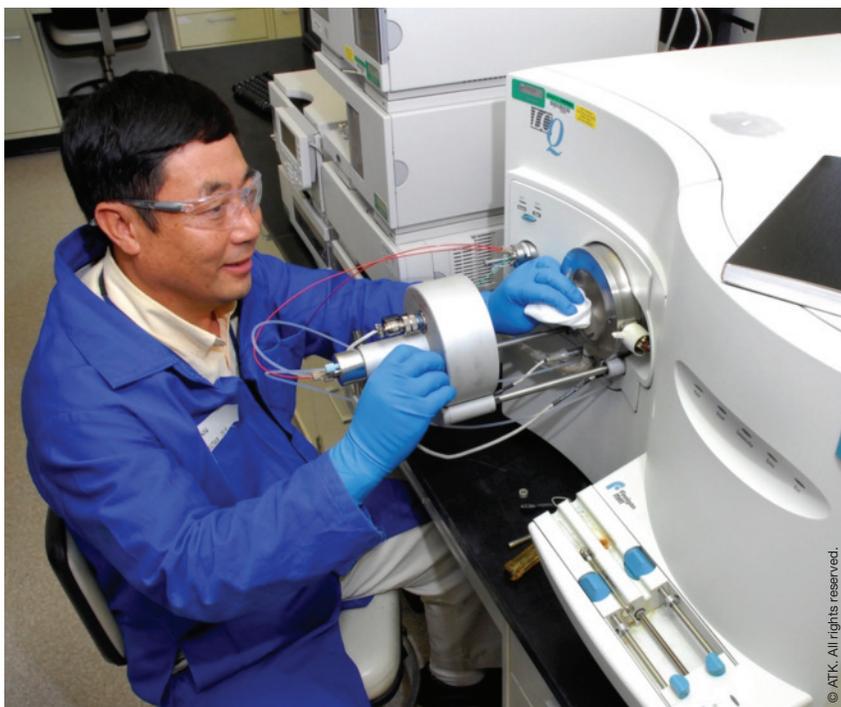
This high-performance liquid chromatography/mass spectrometry is employed to document minute details of a material's chemical and molecular composition. Through the chemical fingerprinting system, seemingly minuscule discrepancies raise red flags that trigger investigations and preclude defective materials from reaching the production floor. Dr. Ping Li shown here at ATK in Utah.

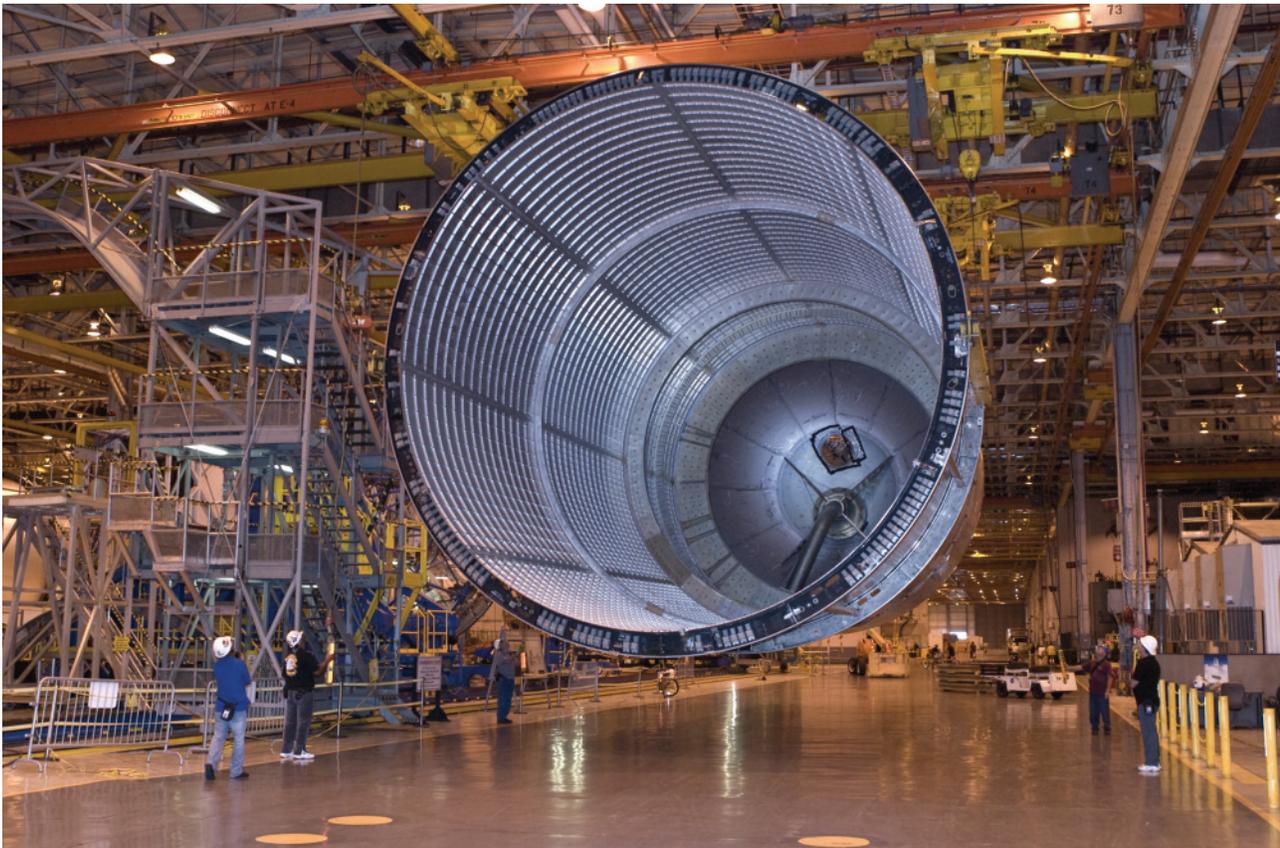
The use of aluminum-lithium Al 2195 in manufacturing major External Tank components, such as the liquid hydrogen tank structure shown above, allowed NASA to reduce the overall weight of the External Tank by 3,402 kg (7,500 pounds). The liquid hydrogen tank measured 8.4 m (27.5 ft) in diameter and 29.4 m (96.6 ft) in length. Photo taken at NASA's Michoud Assembly Facility in New Orleans, Louisiana.
